## COMPONENT 4

# SETTING UP AND OPERATION OF A PILOT CENTRE PIVOT IRRIGATION SCHEME AMONG CONTIGUOUS SMALL CANE FARMING HOLDINGS

Component Leader: Lancelot White  
Sugar Industry Research Institute  
Kendal Road, Mandeville  
Jamaica

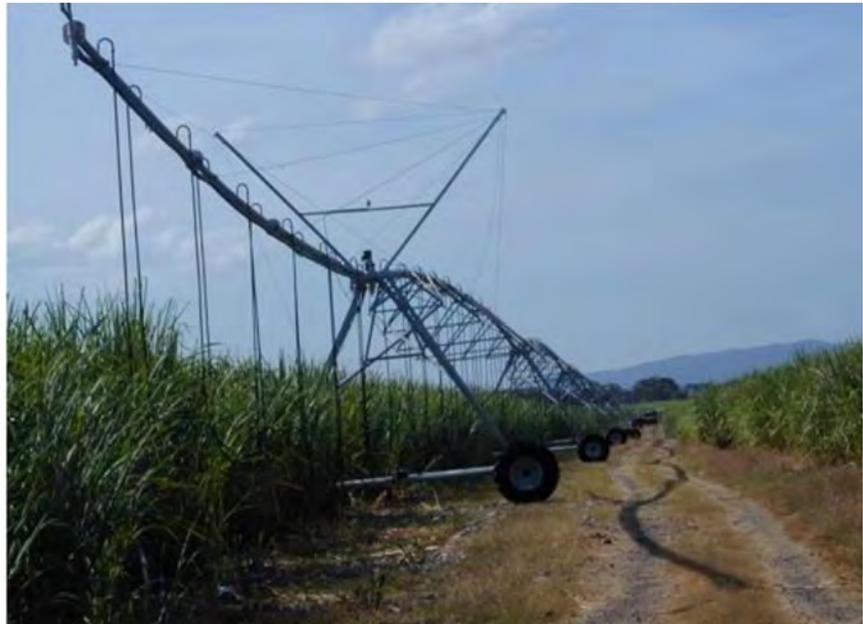
Fig. 1: Centre Pivot in Content, Clarendon

The process of installing a centre pivot scheme, Fig 1, to serve a group of contiguous cane farms in Content, Clarendon, started in 2004 with the tendering, evaluation of bids and awarding of contract. Installation and commissioning was achieved by August 2005. Natural rainfall immediately following commissioning was so great that the pivot was hardly used and therefore had little influence on the crop reaped in 2006. The first harvest for which water would have been largely supplied by the pivot was therefore that of 2007.

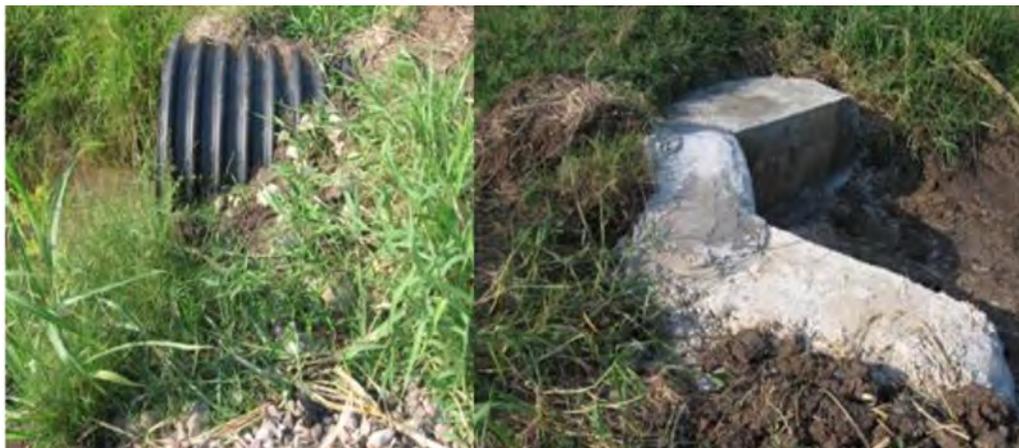
Fig. 2: Ribbed Polyethylene Pipe used for Culvert Crossings

Several main drains and gully crossings that impeded rotation of the pivot were also targeted for remedial work. By the first half of 2006, culverts were established consisting of ribbed polyethylene (P.E) reinforced pipes and concreted outlets/inlets installed to facilitate smooth passage of the pivot wheels across gullies, Fig.2. These P.E pipes, although quite sturdy, served the intended purposes initially but collapsed under the heat of pre-harvest burning. They were subsequently re-

placed with more sturdy and fire resistant reinforced concrete culvert pipes.

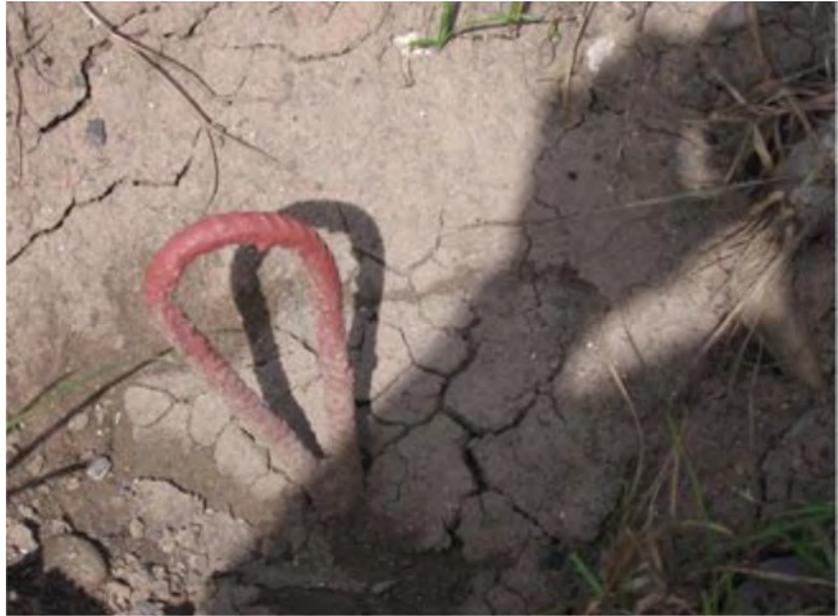
Fig. 3A Centre Pivot Steel Anchor

Secured anchors comprised of buried reinforced concrete at approximately 1.5 m depths along the parking interval were constructed during the first half of 2006. In preparation for hurricane, steel cables were affixed to these anchors and looped over the pivot to hold it in position. These constituted precautionary measures to safeguard the system against excessive damage, Figs 3A & 3B.

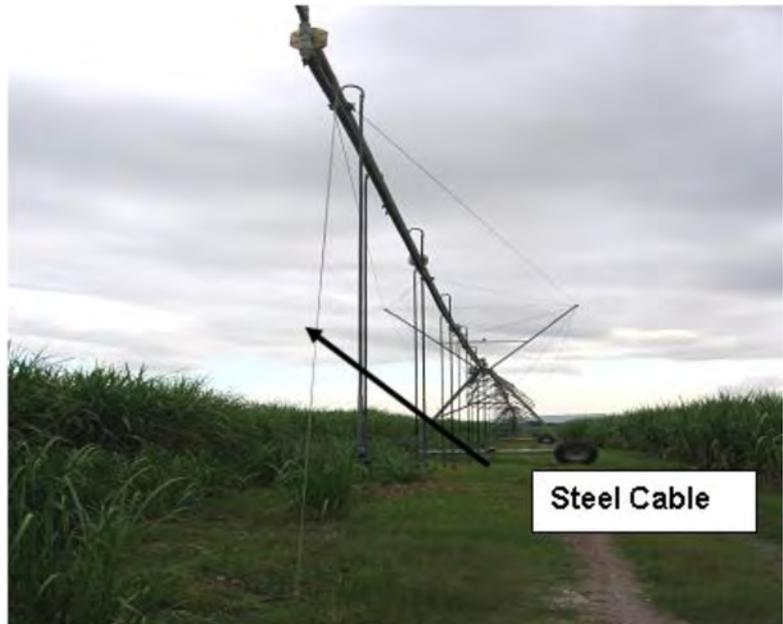
Fig. 3B Steel Cable used for Hurricane Straps

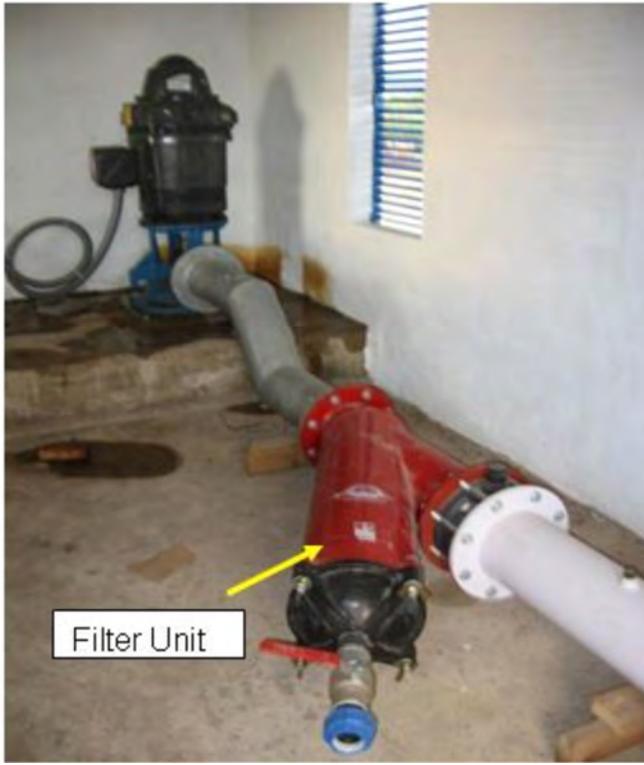
Fig. 4 Screen Filter System

The pivot was designed to deliver water at a flow rate of over 800 gpm. On several occasions a flow of only some 50% of design capacity was detected using a DCT 1088 Ultrasonic Flow Meter for measuring ultrasonic signal strength. This prompted investigations into the main causes of such wide deviations. It was found that the filter system was frequently clogged with debris and aquatic growth from the open canal water source being used. This filter, Fig. 4, had to be routinely flushed to restore signal strengths of over 95%. As an added safeguard, an extra pair of filters was acquired. This has since reduced the pivot downtimes occasioned by the routine cleaning of the filter.

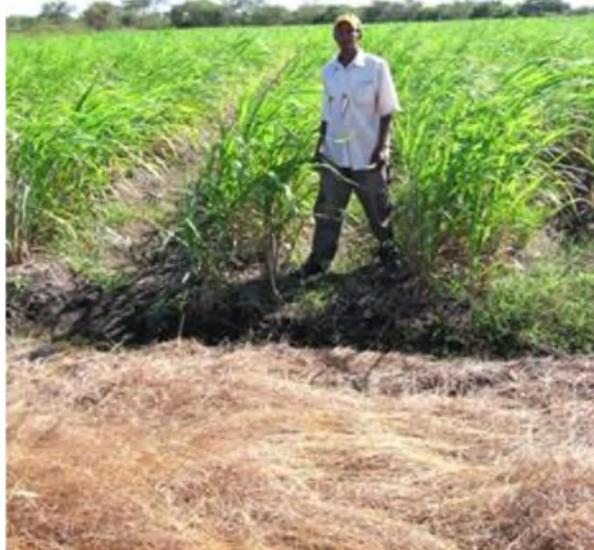
Fig. 8 Dual Row Drip Irrigated Field, Nugent's Farm

Most of the plots were not been harvested and sold to the factory as mature cane in the first year. Vigorously growing plant canes, as produced in these plots, are usually in high demand for use as seed cane, Fig 8. The fact that they were all elite varieties made them even more attractive to potential purchasers. Several of the plots were therefore harvested within 5-7 months and material sold as commercial seed cane to other growers. Seed cane sale is usually more profitable than mature cane sold to the factory as price per tonne is competitive and it is feasible to complete two harvests of seed cane in

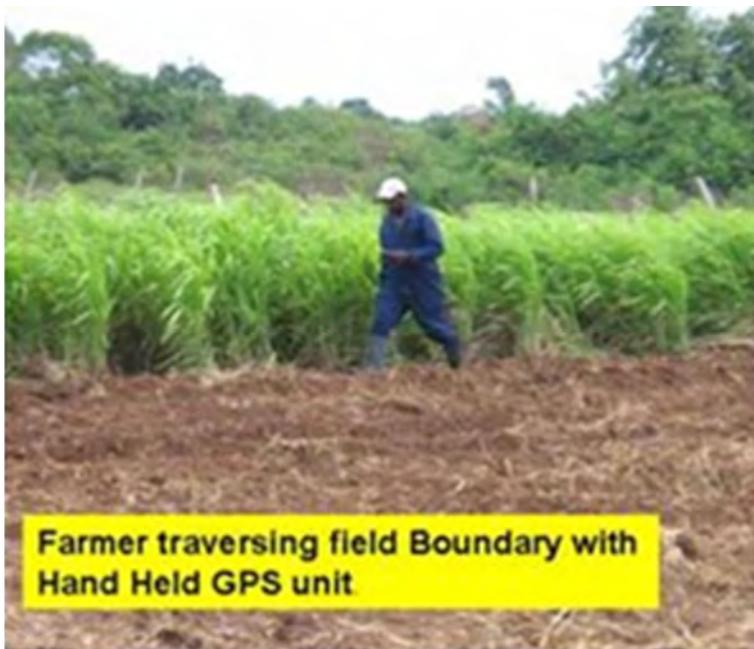
Fig 10 Mapping using Garmin Hand Held GPS Unit

plished through use of GPS handheld instruments, figure 10. Land preparation began in June, 2006.

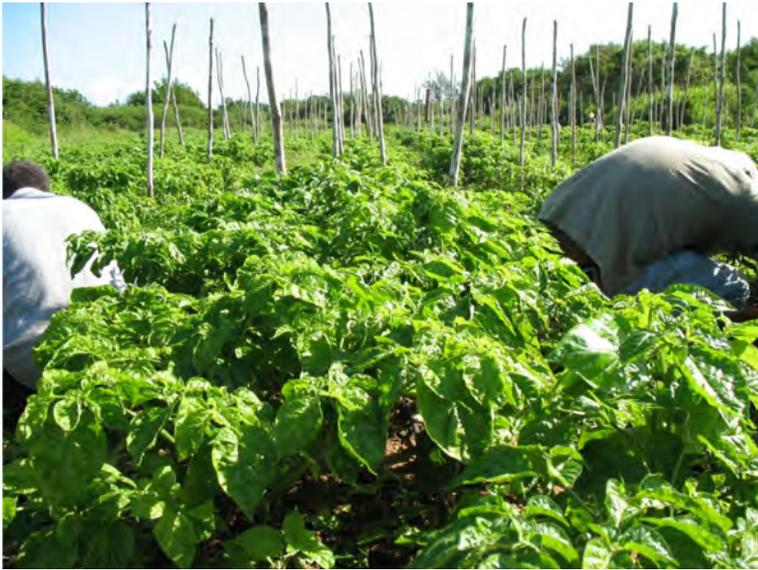
Fig 11 : Drip irrigated plot of Scotch Bonnet Pepper, Braco, Trelawny

Under the guidance of the project leader responsible for the Crop Diversification component of the project, plots were eventually planted to crops such as carrot, escallion, cantaloupe, Caribbean red pepper, Scotch Bonnet pepper, figure 11.
